Through-Bolts in the Top Chord of Steel Joists

A Problem Sway Brace Attachment

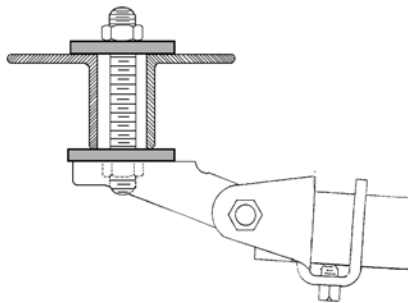
Through the years many sway brace connections to open web steel joists have been accomplished by bolting through the gap at the top chord of a joist, which exists between the parallel angle iron elements. Some contractors have used a **fender washer assembly** consisting of a 1/2" threaded stud assembled with two fender washers and nuts to provide engagement, see **Figure #1**. This practice became common in the fire sprinkler industry because joist manufacturers discourage welding to or drilling through the top chord elements, due to concern about reduced load capacity. Despite the use of the fender washer assembly being common practice, it is not structurally adequate nor does it meet the requirements of NFPA-13 for sway bracing. The following text supports this position.

1999 NFPA dictates bore-fit for bolts per section 6-1.5.3 "Holes for bolts shall not exceed 1/16" greater than the diameter of the bolt." Even though this criterion is not explicitly in section 6-4 on Seismic requirements, it still applies as a general hanging and bracing requirement. The top chord gap is not a hole or bore. It is a slot that has a minimum 3/4" width and an indeterminate length. As such, the subject through bolt ALWAYS violates 6-1.5.3 along the top chord.

A second violated requirement is NFPA13: 6-4.5.10 that requires the brace fittings and connections shall be listed. This is also covered by 6-1.1.1 that states "The components of hanger assemblies that directly attach to the pipe or to the building structure shall be listed." The fender washer assembly is NOT listed. It in fact failed UL sway brace test criteria performed in AFCON's laboratory.

Figure #1
Incorrect Joist Connector

The fender washer assembly does NOT meet fastener bore criteria or the sway brace listing criteria. If you are using it, I advise you to cease because it's only a matter of time before AHJ's perceive this deficiency. Do it correctly using listed product or drill/weld as approved by the joist manufacturer. AFCON #085 is a listed direct replacement for the fender washer assembly, see **Figure #2**. The geometry of this adapter, though similar to the fender washer assembly regarding bore hole, is different and was driven by the demands associated with it passing the listing test criteria. Its' listing verifies that it is not only structurally adequate but also capable of withstanding the dynamic forces created by an earthquake. Other manufacturers have listed sway brace adapters to provide a connection at different orientations. We hope these facts help to provide a correct solution to your installation strategy.
